**National Transportation Safety Board  
Office of Marine Safety  
490 L'Enfant Plaza  
Washington D.C. 20594**

**Collision between the USS Greenville and the M/V Ehime Maru  
Off Honolulu, HI, on February 9, 2001**

**DCA 01 MM 022**

**Vessel Damage Factual Report**

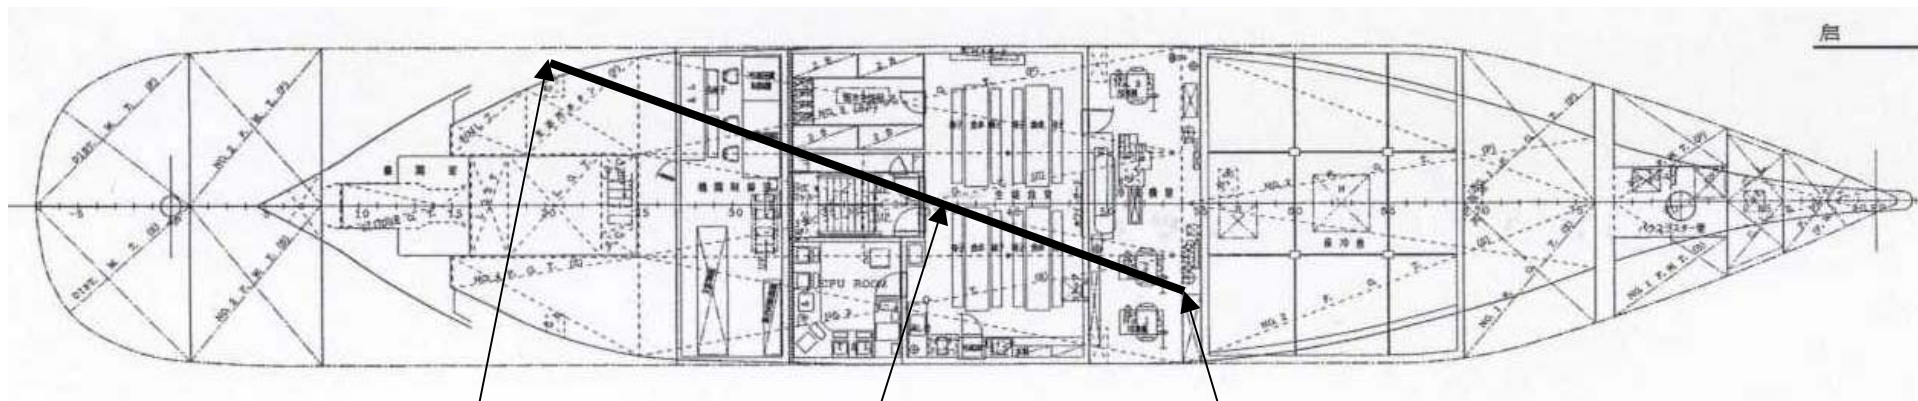
**Figure 1 - Line of cut in inner and outer bottom of Ehime Maru**

A underwater survey of the vessel's bottom was later conducted by the US Navy using cameras mounted on a ROV, when the EM was raised off the sea bed for transportation to shallow water. The survey revealed a cut in the hull that began on the starboard side inboard of the bilge keel on the flat of bottom at frame 54 (near the deckhouse front). The cut, between 2 to 3 feet wide, ended on the port side shell at frame 21 in the vessel's engine room, where it extended vertically from the vessel's bottom to 11.5 feet (3.5 m) above it (the design waterline mark). At frame 21 the jagged edges of hull plating pointed outboard to port.

After the EM was transported to shallow water and set down on the ocean floor, divers for the Japanese authorities entered the interior of the vessel to search for bodies and record the damage on videotapes. Videos of the vessel's interior showed that, as the cut proceeded from forward to aft of the vessel, it had breached the vessel's innerbottom in the Students Mess, the Stairwell and the Engine Control room. The cut then proceeded through the bulkhead between the control room and the engine room, leaving a vertical cutout in the bulkhead, in the approximate shape and size of the Greenville's upper rudder. The vertical outline of the rudder was also clearly visible on the port side shell of the EM's engine room, through which the submarine's upper rudder had exited the EM's hull. The line of cut had also breached several double bottom (DB) tanks; going forward to aft these tanks included No.2 Fuel oil DB tank (Starboard), No. 3 Fuel oil DB tanks (Starboard and Center) and No.4 Fuel oil DB tank (Port) in the engine room.

The sandy bottom was clearly visible on camera from inside the vessel establishing that both outer and innerbottoms had been cut through. Damage to the control room was evidenced on tape by pictures of control panels, desks, chairs, telephones and acoustic insulation panels. Damage to the interior of the students mess and vertical stairtower on the port side of the Computer (CPU) room was also visible on tape. The open vertical stairtower would allow water to immediately flood upwards to the upper deck levels in the vessel.

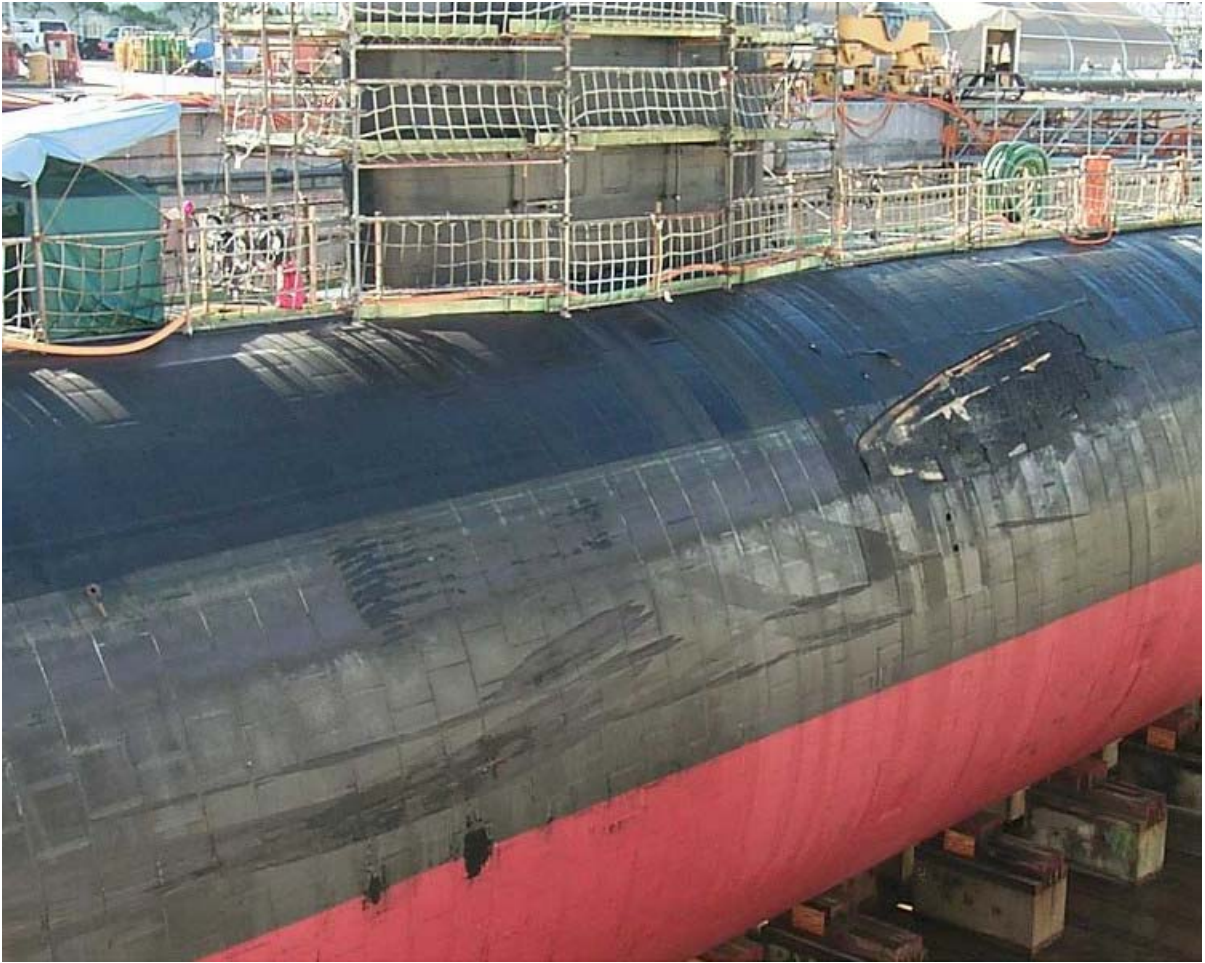
**Figure USS Greenville – Damage to Port Hull**

Safety Board investigators conducted a damage survey of the USS Greeneville in drydock at Pearl Harbor Naval Shipyard. Investigators found that the sail of the submarine showed no damage. Immediately below the sail, the acoustic hull surface treatment (tiles) on the portside hull had been sheared off in an elliptical pattern (see Photo 1 Hull Scrapes). The ellipse was about 24 feet long, starting 2 feet below the waterline at frame 50 and extending to frame 58. Going forward to aft the ellipse was inclined upwards at 20 degrees to the horizontal. The upper boundary of the ellipse showed a clean cut while the lower edge was jagged.

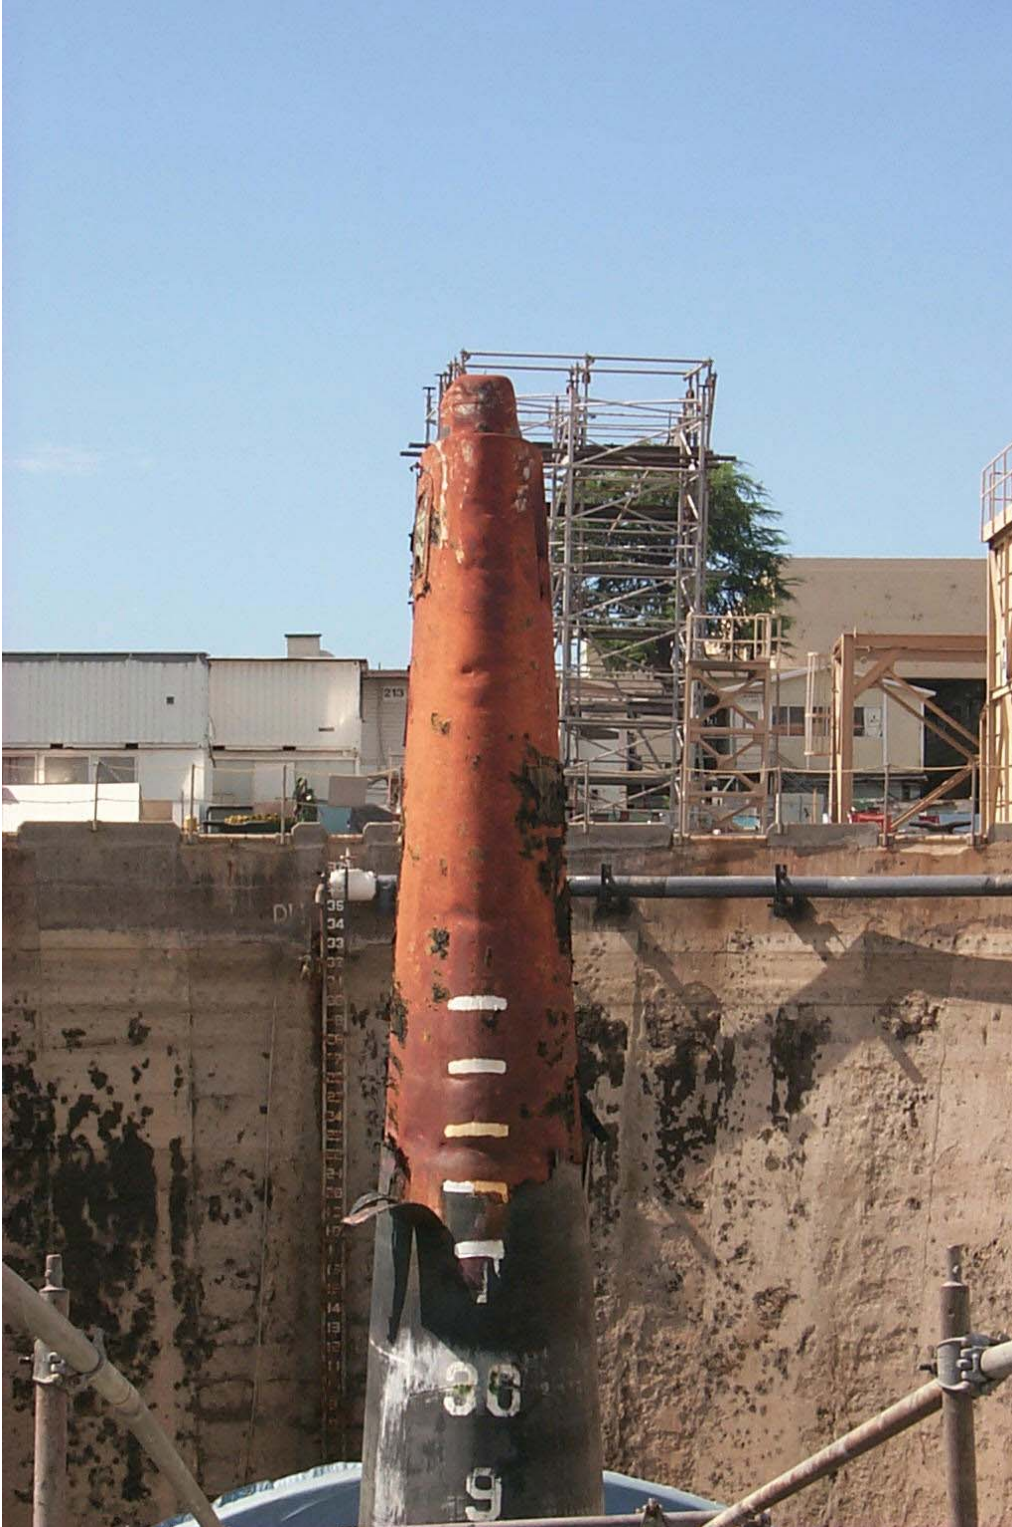
**Figure** USS Greenville – Damage to Upper Rudder, view from leading edge

The upper rudder, located at the submarine’s stern, showed the greatest impact damage (Photo Damage to Leading Edge of Upper Rudder). Damage began at the 31 foot draft mark and extended all the way to the top of the upper rudder on both its port and starboard sides (Photos of Damage to Port and Starboard Sides of Upper Rudder). Surface tiles had been sheared off exposing bare metal over most of the rudder surface and there were several indentations on the rudder’s leading edge. One of the larger indentations had punctured the metal skin on the port side. The anchor light had been sheared off the top of the rudder. Surface tiles on the hull had been partially torn immediately to starboard of the trailing edge of the upper rudder. Other scrapes and
